# Federal Aviation Administration

Subject: ACTION: Report of Investigation of Whistleblower Complaint Number WB17582, Southwest Airlines, Inc.

**Report of Investigation  
Whistleblower Complaint  
EWB17582**

Whistleblower Complaint Number EWB17582

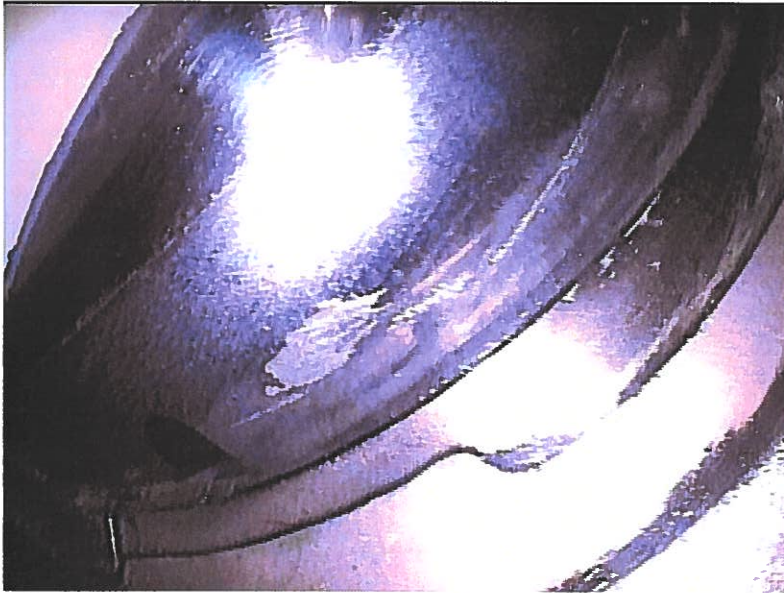
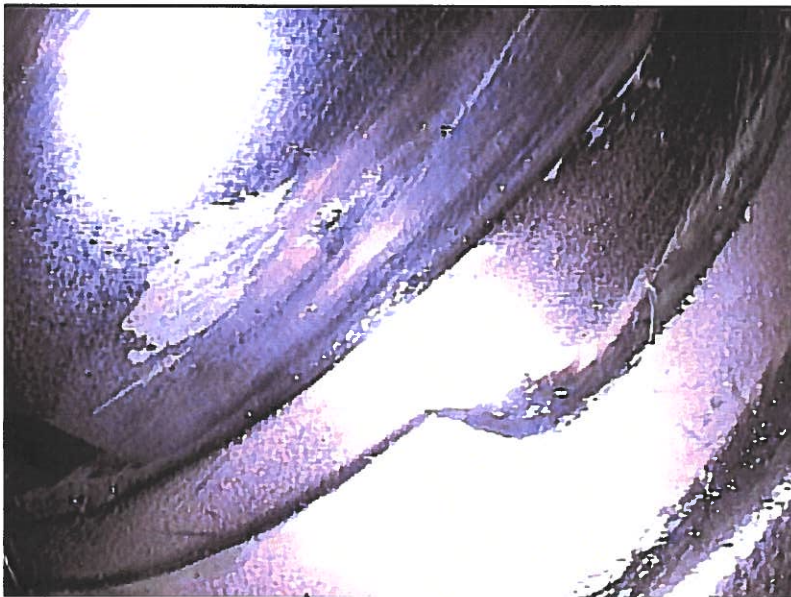
APPENDIX A  
FIGURE 1

Item 26 of the Complaint, alleges a trunnion pin was not removed for further inspection as a result of the initial detection of corrosion.

Trunnion pin image showing finding.  
N787SA, Serial Number 29812, a Boeing 737-7H4  
(Item 26 within the complaint)

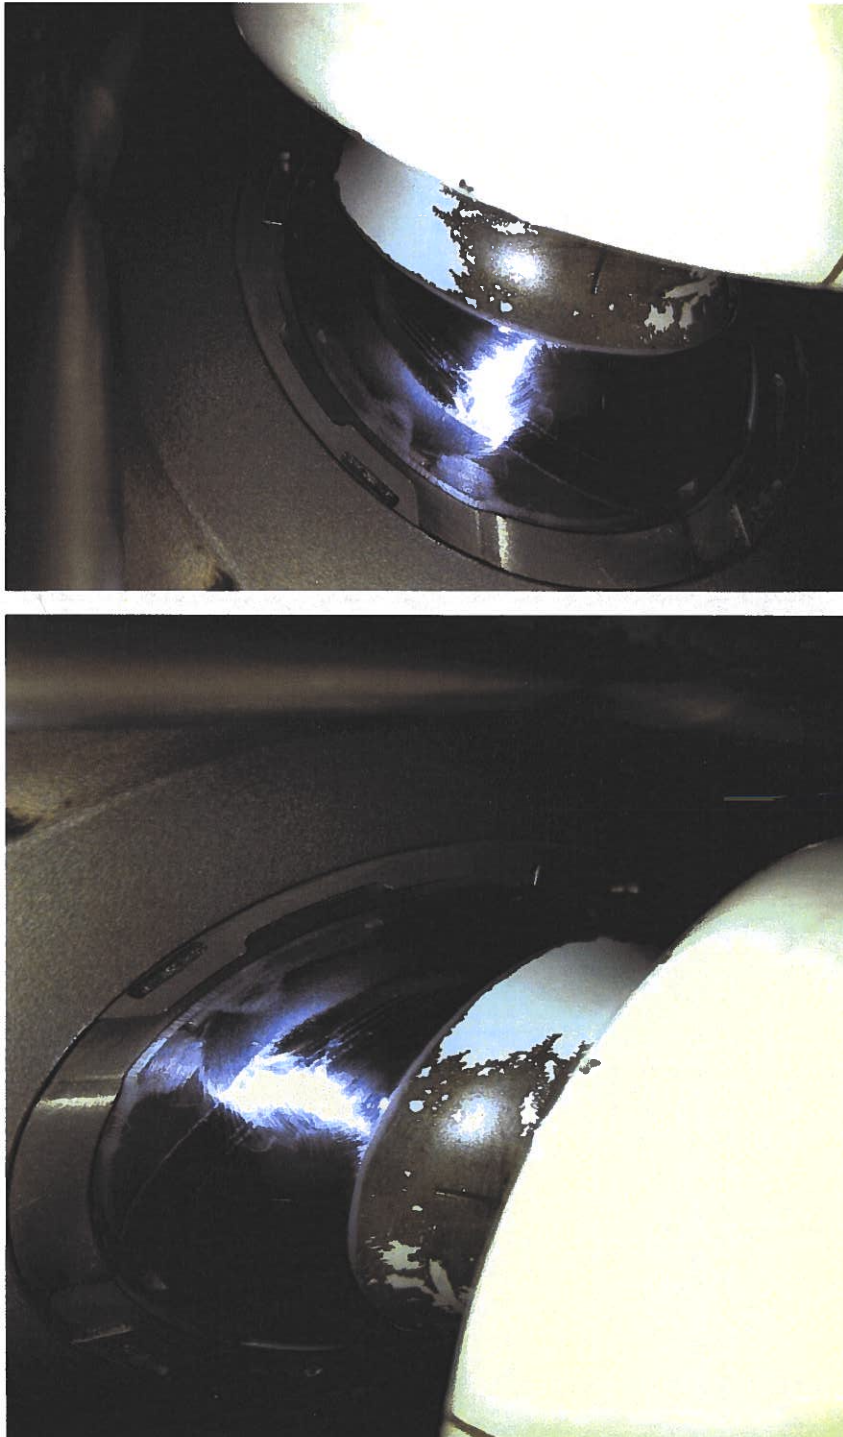
FIGURE 2

Trunnion pin demonstrating no missing chrome.  
N787SA, Serial Number 29812, a Boeing 737-7H4  
(Item 26 within the complaint)

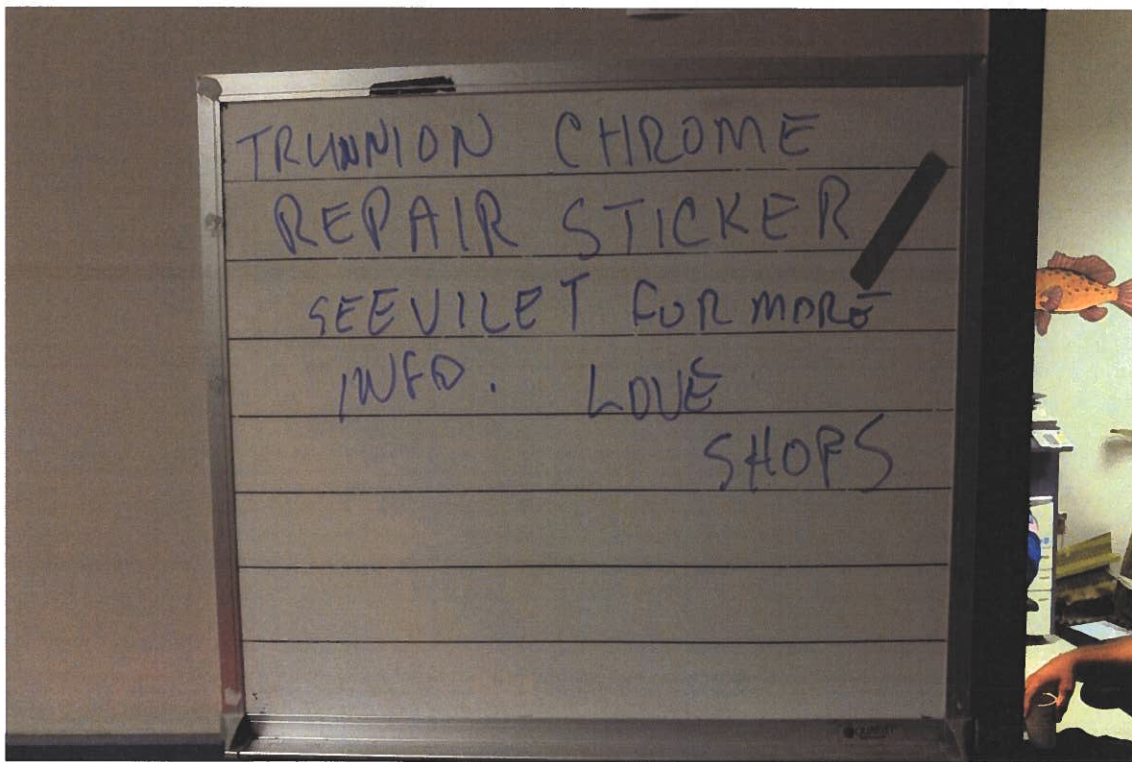
FIGURE 3

Hazing note left for (b) (7)(C) involving trunnion pin.  
N787SA, Serial Number 29812, a Boeing 737-7H4  
(Item 26 within the complaint)

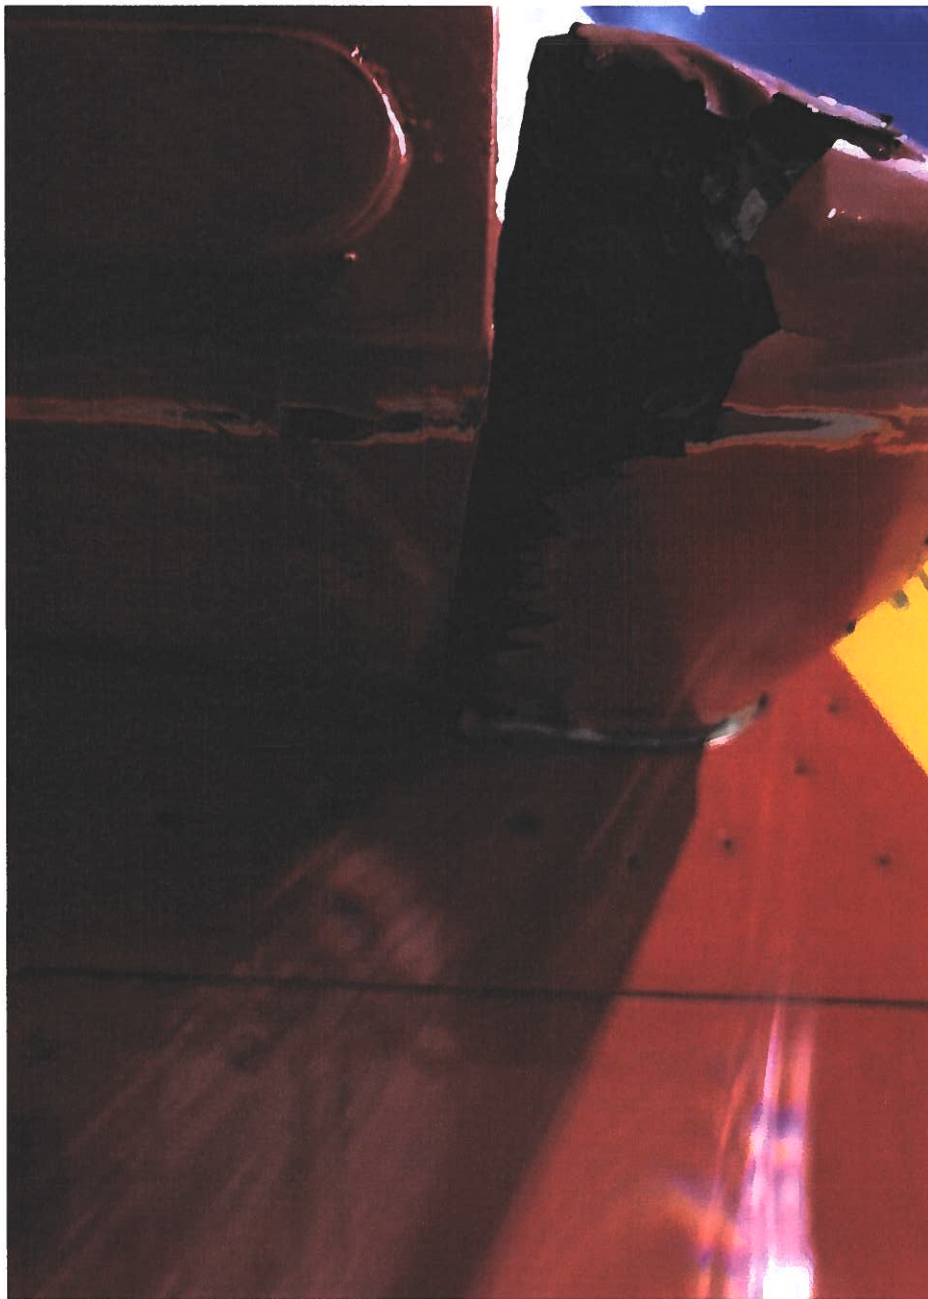
FIGURE 4

Item 30 of the Complaint, alleges (b) (7)(C) responded in a hostile manner to Complainant Mullins and demanded to know how Complainant Mullins came to be in a position to detect the discrepancy of corrosion on the rudder weight and the wobbling back and forth of four connecting bolts.

Rudder Balance Weight Damage  
N242WN, Serial Number 32505, a Boeing 737-7H4  
(Item 30 within the complaint)

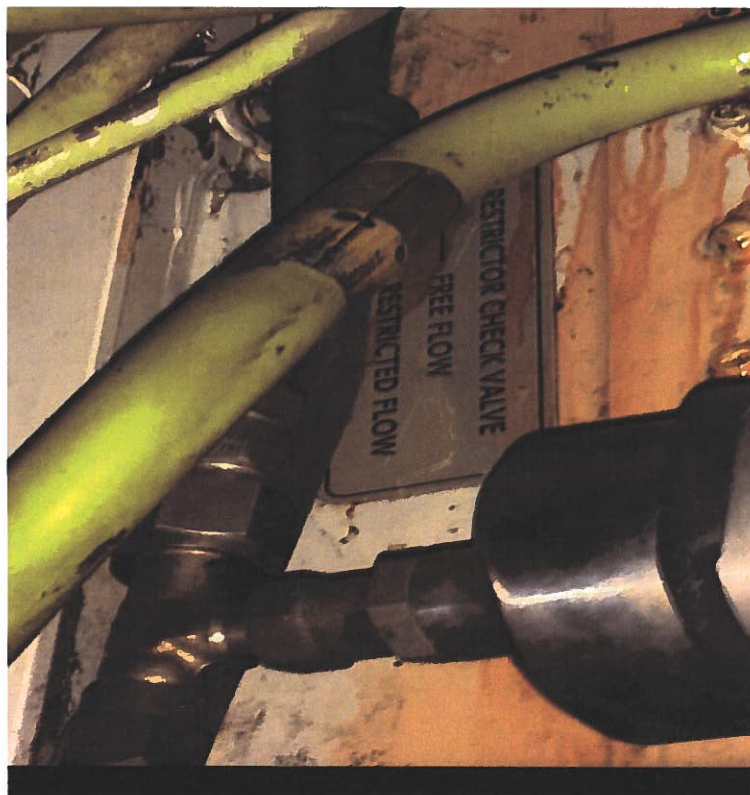
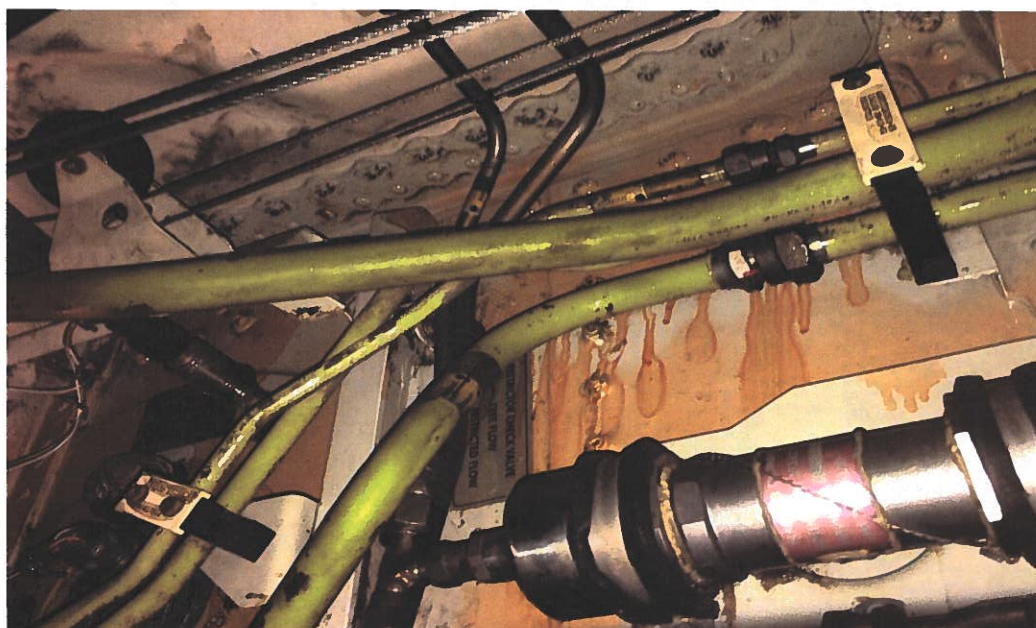
FIGURE 5

When interviewed, Complainant Zabransky alleged the discrepancies that occurred in November were related to the discrepancy of the right main landing gear being slow to retract and that the problem was due to a restrictor/check valve that was found installed backwards. Complainant Zabransky believes the valve was installed backward back in November 2015, when Southwest received the aircraft.

Images of restrictor/check valve to tee connection with placard in background. Tee connected to transfer cylinder.

Taken for illustration purposes only related to COMPLAINT ALLEGATION # 4.  
(Item 16 within the complaint)
